### 1. Rock crusher and bins

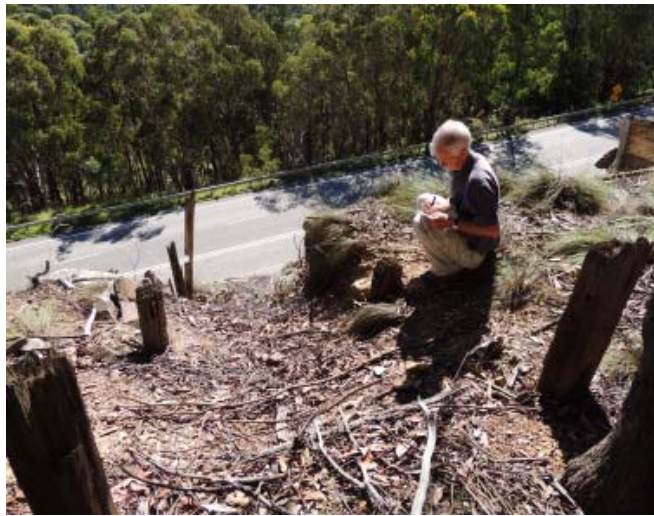
FIGURE 7.11: At the left of photo is a row of posts which were the left side of the input chute structure. I'm squatting next to a post stump from the right side and there's another post near me. Photo by Brian Fox, 2015.

On the western side of the crusher was the chute, part of which was still there in 2015 (Figures 7.11, 7.12). Four timber posts, 15cm x 15cm (6in x 6in), are still in position. They supported a roof over the chute. (See Figure 3.7 on p60.) The bottom of the chute was lined with timber planks, some of which are still there.

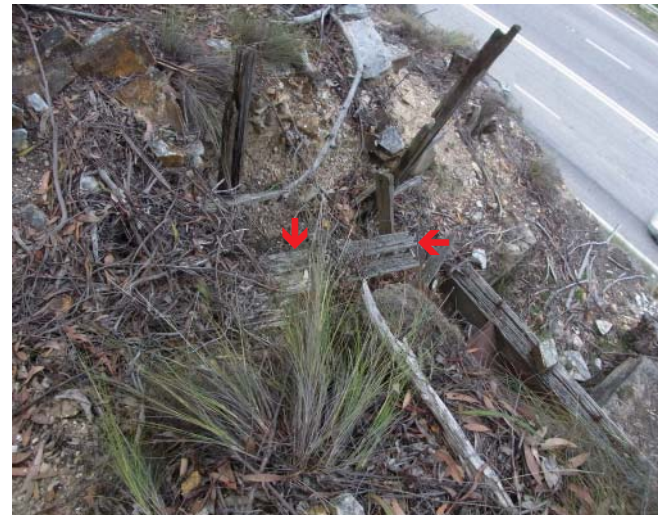
FIGURE 7.12: Looking at the input chute from the right side. The timber board (red arrows) was probably part of the floor of the chute. The chunks of chert would have tumbled down the chute into the crusher. (Oct. 2014)

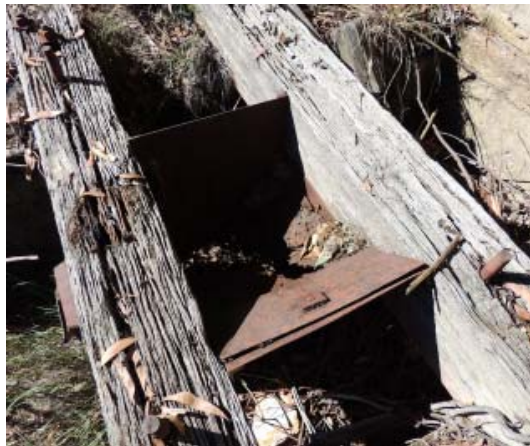
FIGURE 7.13: The two timber beams would have supported the crusher — see the bolts that secured the machine. The crushed stone fell between the steel plates through the angled steel chute onto the conveyor belt. Photo by Brian Fox, 2015.

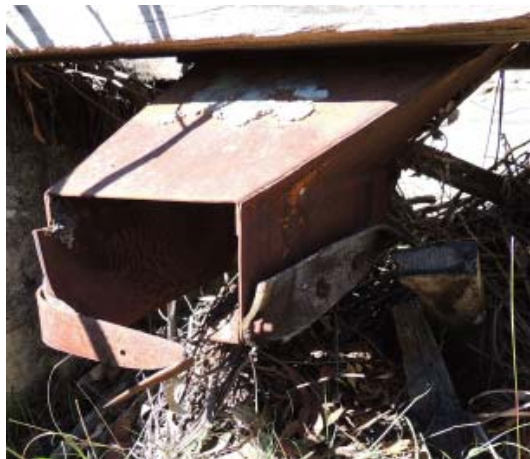
FIGURE 7.14: Close-up view of the chute from below. Photo by Brian Fox, 2015.

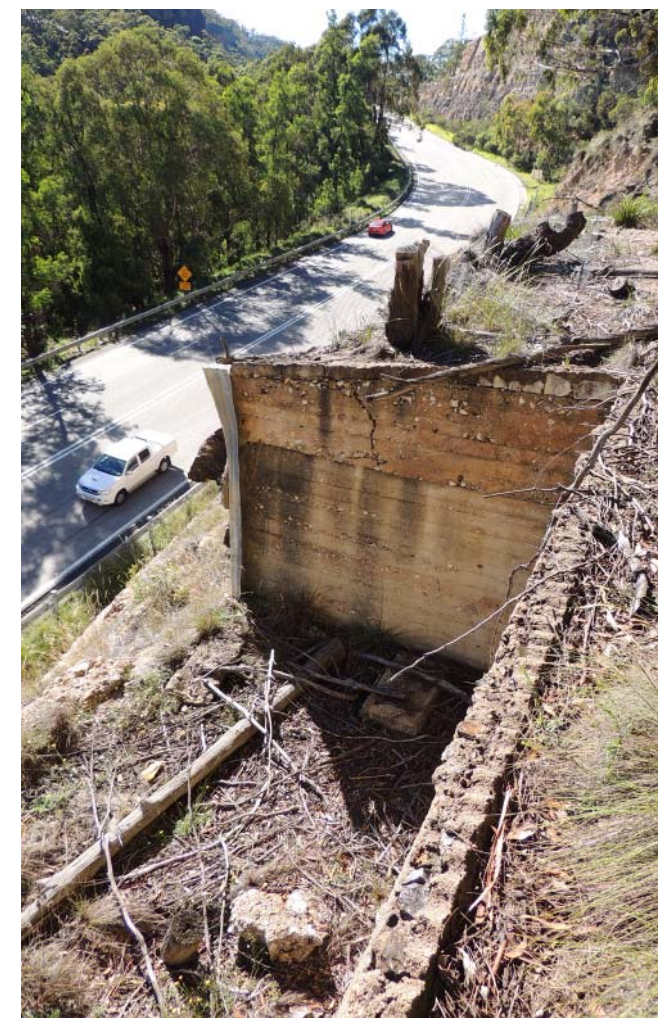
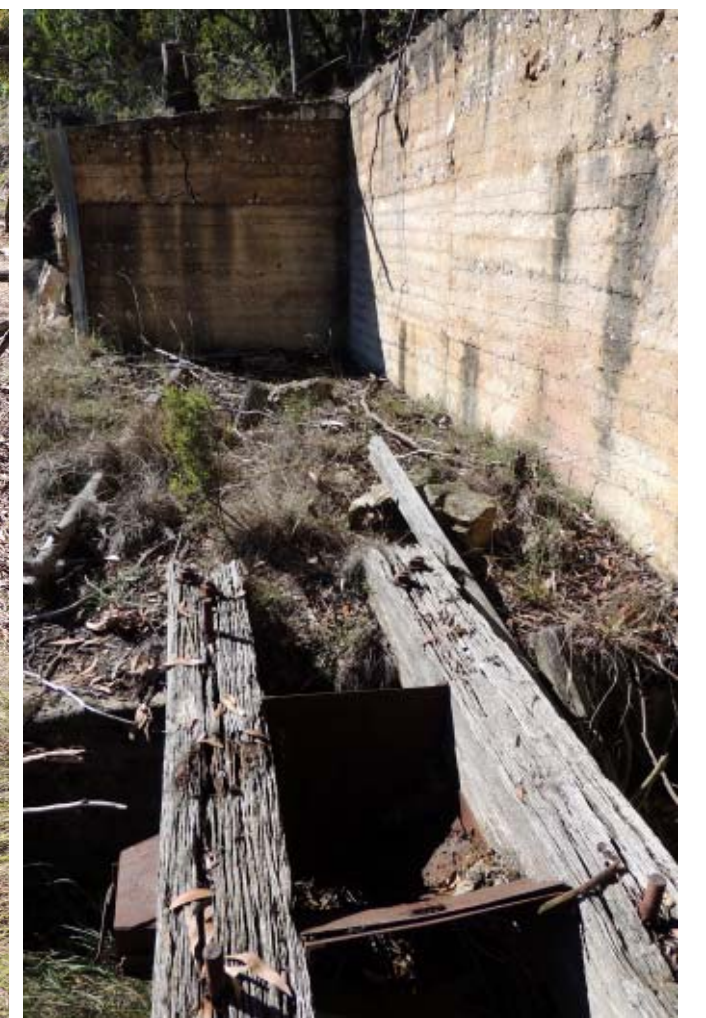
The two photos above and the one at bottom left show the concrete structure that housed the Jaques rock crusher.  
 Top left — FIGURE 7.15: Looking down and east, from above. Note the concrete base for the motor in the right corner. (See photo at bottom right.)  
 Top right — FIGURE 7.16: Photographed from within the structure looking east towards Mitchells Causeway. Note the timber beams and steel plates of the chute that was below the crusher. Also the bolts which secured the crusher to the beams.  
 Bottom left — FIGURE 7.17: Looking west from within the structure. The jumble of timbers just beyond the steel chute were part of the chute into which chert was tipped to fall down into the crusher. The conveyor belt would have started below the steel plates and carried the crushed chert to the rotary screen for sizing and into the bins which would have been to the right and below.  
 Photos by Brian Fox, January 2015.

A concrete structure, which housed the Jaques rock crusher, can still be seen from the Highway. It's 8.7m (28ft 6in) long, 3.36m (11ft 3in) wide and about 2.5m (8ft 2in) high (Figures 7.15 to 7.18). The base of it has two timber beams, 27cm x 29cm x 2.6m (10½in x 11½in x 8ft 6in), parallel to the longest dimension (Figures 7.13, 7.16). The ends of the beams are secured to the concrete floor with two bolts. The crusher was probably bolted to these beams with another four bolts, three of which are still in the timbers. Between the beams are two steel plates, one appears to be vertical, the second at an angle (Figures 7.13, 7.16). The crushed chert fell between these plates through a chute (Figure 7.14) on to a conveyor belt and rollers which took it to a rotary metal screen for sizing and sorting into the relevant bins. The metal was crushed into gauges of 2½in, 1½in and ¾in. The bin structure was divided into four compartments and could hold 150 tons.

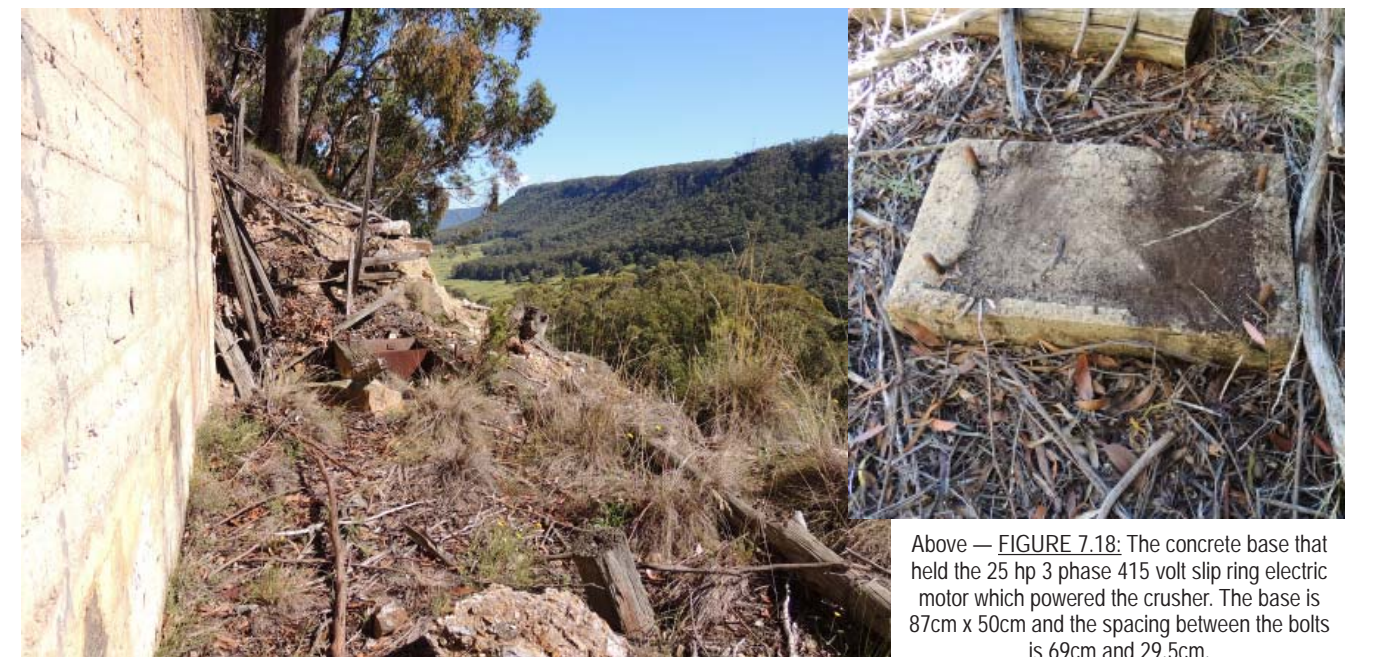
Above — FIGURE 7.18: The concrete base that held the 25 hp 3 phase 415 volt slip ring electric motor which powered the crusher. The base is 87cm x 50cm and the spacing between the bolts is 69cm and 29.5cm.

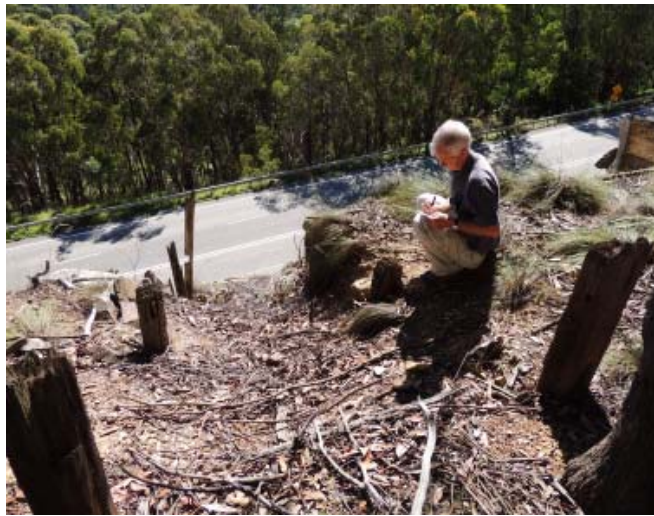
FIGURE 7.11: At the left of photo is a row of posts which were the left side of the input chute structure. I'm squatting next to a post stump from the right side and there's another post near me. Photo by Brian Fox, 2015.

On the western side of the crusher was the chute, part of which was still there in 2015 (Figures 7.11, 7.12). Four timber posts, 15cm x 15cm (6in x 6in), are still in position. They supported a roof over the chute. (See Figure 3.7 on p60.) The bottom of the chute was lined with timber planks, some of which are still there.

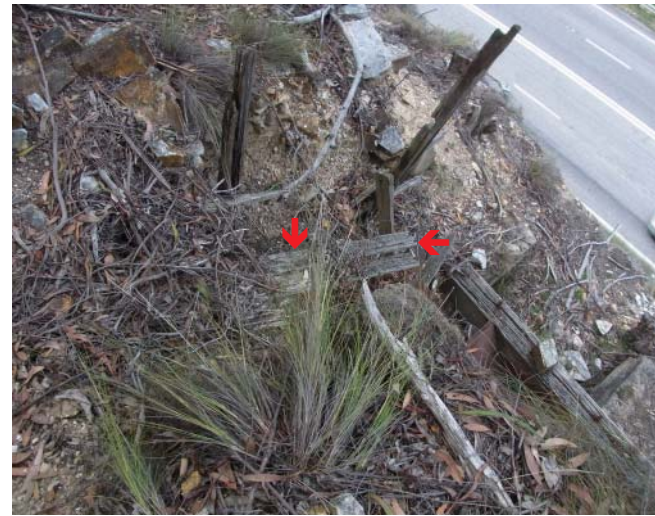
FIGURE 7.12: Looking at the input chute from the right side. The timber board (red arrows) was probably part of the floor of the chute. The chunks of chert would have tumbled down the chute into the crusher. (Oct. 2014)

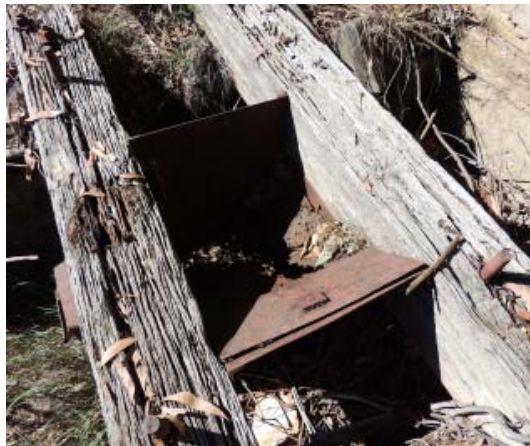
FIGURE 7.13: The two timber beams would have supported the crusher — see the bolts that secured the machine. The crushed stone fell between the steel plates through the angled steel chute onto the conveyor belt. Photo by Brian Fox, 2015.

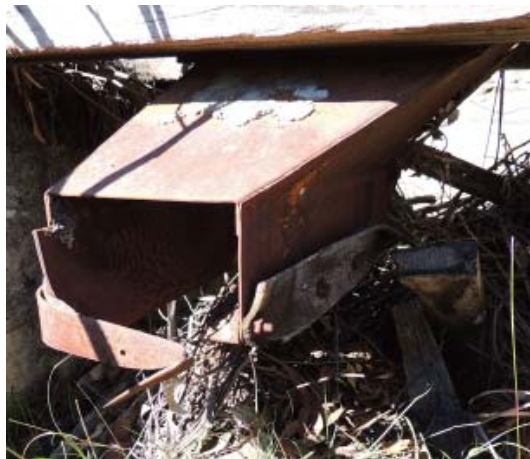
FIGURE 7.14: Close-up view of the chute from below. Photo by Brian Fox, 2015.

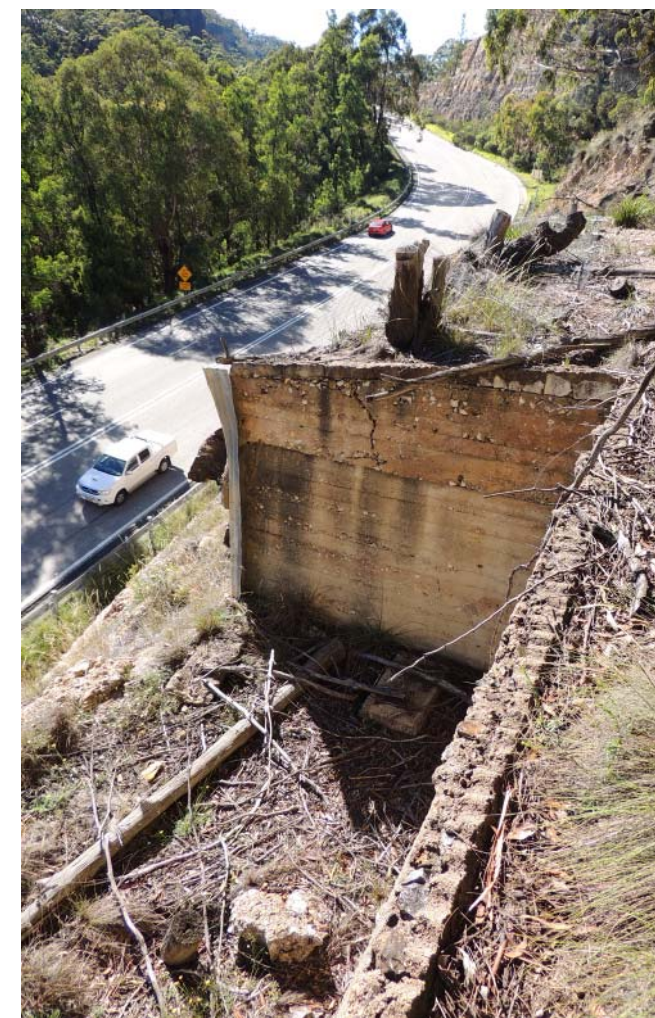
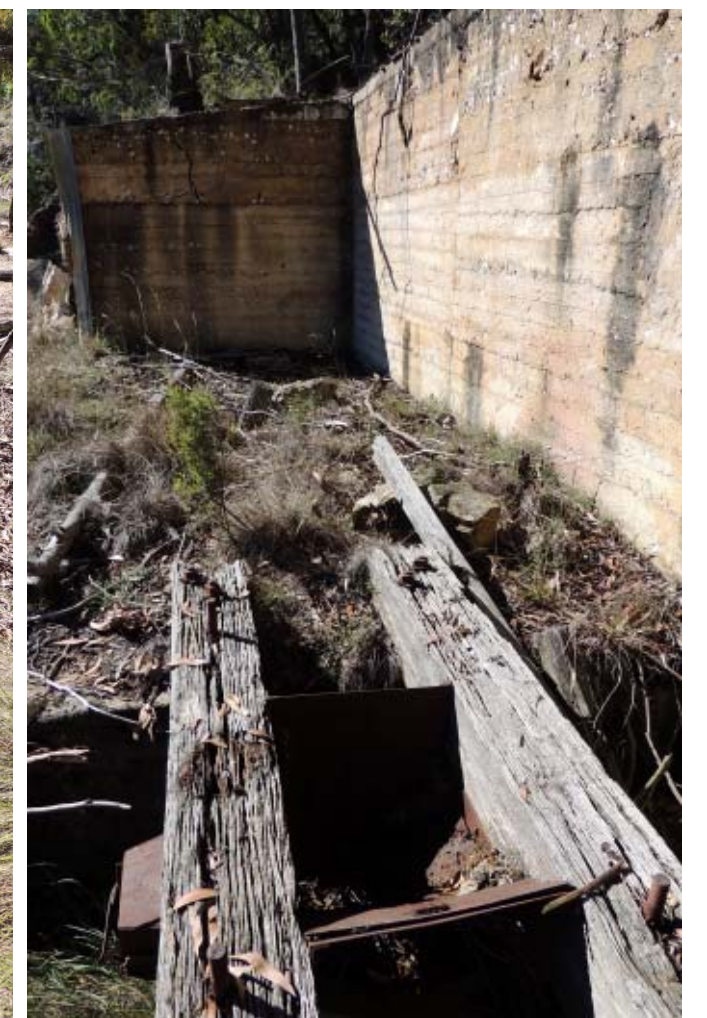
The two photos above and the one at bottom left show the concrete structure that housed the Jaques rock crusher.  
 Top left — FIGURE 7.15: Looking down and east, from above. Note the concrete base for the motor in the right corner. (See photo at bottom right.)  
 Top right — FIGURE 7.16: Photographed from within the structure looking east towards Mitchells Causeway. Note the timber beams and steel plates of the chute that was below the crusher. Also the bolts which secured the crusher to the beams.  
 Bottom left — FIGURE 7.17: Looking west from within the structure. The jumble of timbers just beyond the steel chute were part of the chute into which chert was tipped to fall down into the crusher. The conveyor belt would have started below the steel plates and carried the crushed chert to the rotary screen for sizing and into the bins which would have been to the right and below.  
 Photos by Brian Fox, January 2015.

A concrete structure, which housed the Jaques rock crusher, can still be seen from the Highway. It's 8.7m (28ft 6in) long, 3.36m (11ft 3in) wide and about 2.5m (8ft 2in) high (Figures 7.15 to 7.18). The base of it has two timber beams, 27cm x 29cm x 2.6m (10½in x 11½in x 8ft 6in), parallel to the longest dimension (Figures 7.13, 7.16). The ends of the beams are secured to the concrete floor with two bolts. The crusher was probably bolted to these beams with another four bolts, three of which are still in the timbers. Between the beams are two steel plates, one appears to be vertical, the second at an angle (Figures 7.13, 7.16). The crushed chert fell between these plates through a chute (Figure 7.14) on to a conveyor belt and rollers which took it to a rotary metal screen for sizing and sorting into the relevant bins. The metal was crushed into gauges of 2½in, 1½in and ¾in. The bin structure was divided into four compartments and could hold 150 tons.

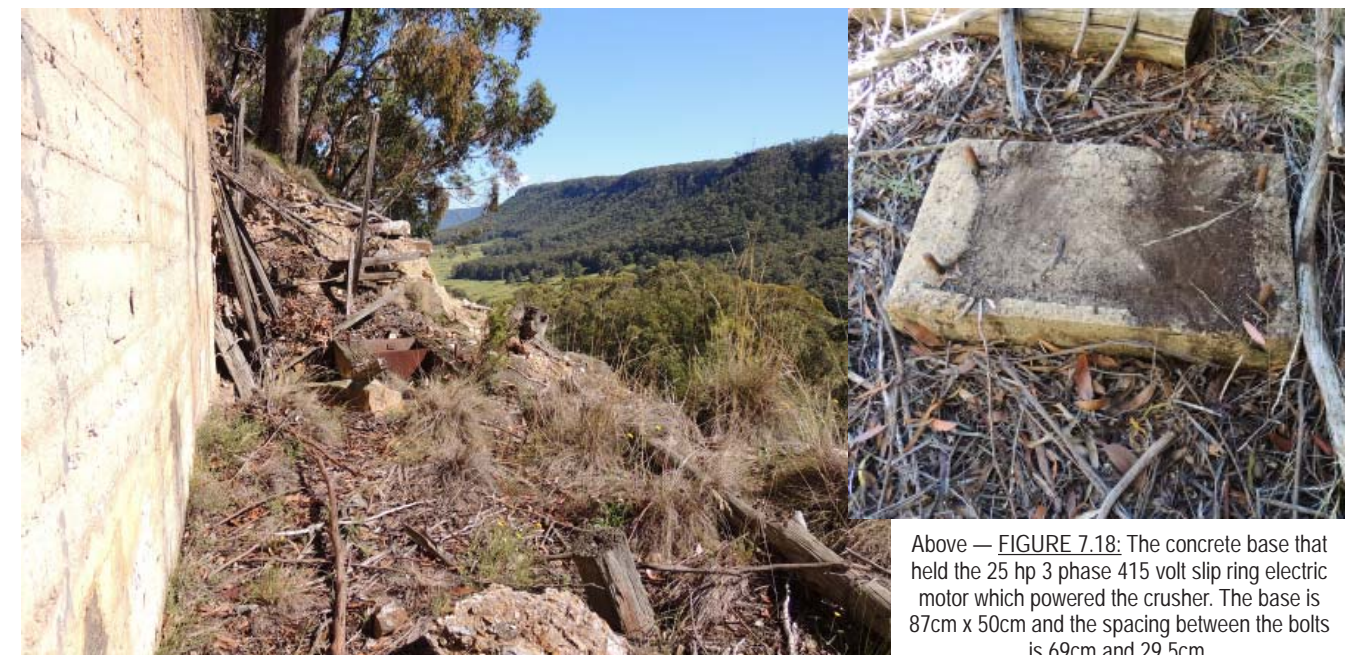
Above — FIGURE 7.18: The concrete base that held the 25 hp 3 phase 415 volt slip ring electric motor which powered the crusher. The base is 87cm x 50cm and the spacing between the bolts is 69cm and 29.5cm.
